# **MELBOURNE CHANNEL DEEPENING PROJECT**

## ***Precis: Verification Report No.1 for Department of Sustainability and the Environment, Victoria, Australia***

### ***Ripper Draghead Compliance Verification***

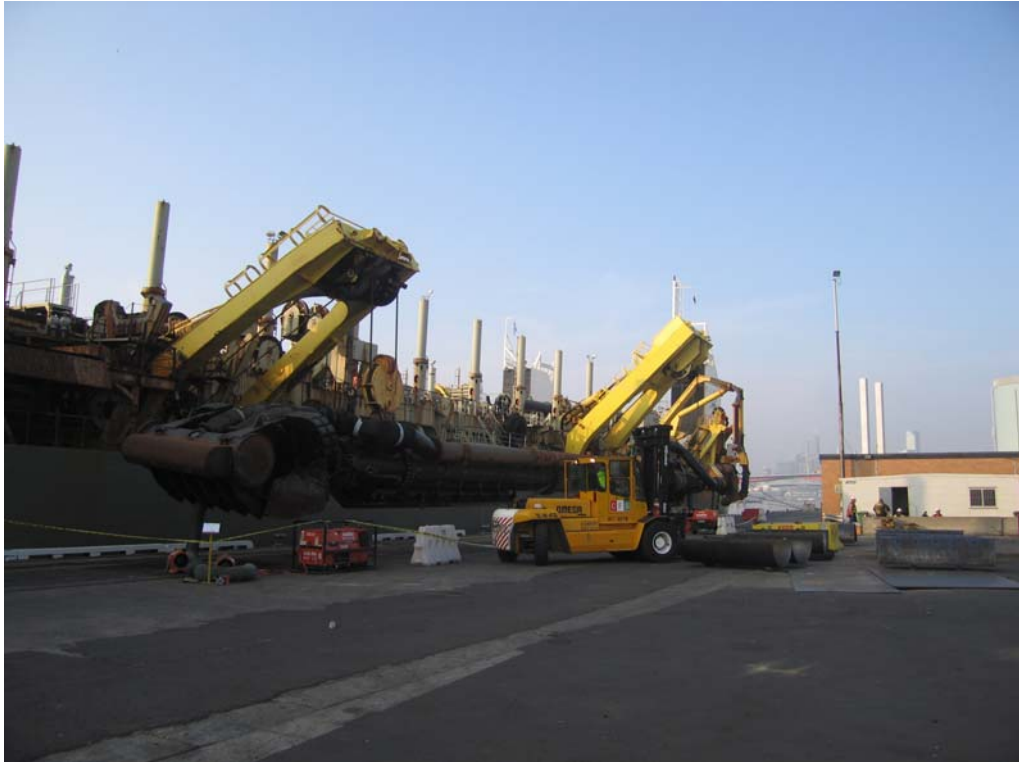
On the 3<sup>rd</sup> June, 2008, the author, accompanied by DSE, DEWHA and PoMC/Boskalis Alliance personnel, visited the quay in Melbourne where the TSHD “Queen of the Netherlands” was docked. The starboard suction pipe and draghead were, at that time, suspended over the quay during a period of maintenance and repair (see Figure 1). From inspection at close quarters it was clear where the water jets were situated, where additional shielding had been added and what other modifications had been made in accordance with the Delft recommendations.

Figure 1: TSHD “Queen of the Netherlands” starboard suction pipe and draghead ready for inspection on 3/6/08

The obstructions noted in Point 3 may be partially eliminated by increasing the size of the apertures leading to the suction pipe. It was unclear from the photographs whether this point had been taken into account in the modified design. However, during the site visit on 3<sup>rd</sup> June, 2008, these apertures were examined and found to be increased in size. Moreover, it was pointed out by Boskalis personnel that an additional anti-blockage plate had been added.

Point 5 is an important finding of the Delft trials, leading to significant improvements in spill reduction, and it is clear from the photographs that serious attempts have been made to shield the sides and upper part of the dragheads to reduce inflow from these directions. These shields were examined during the site visit and found to be fully functional.
