Turbidity Monitoring Locations North of the Bay – All Sites

Interpretation of weekly turbidity monitoring results, released 1 October 08

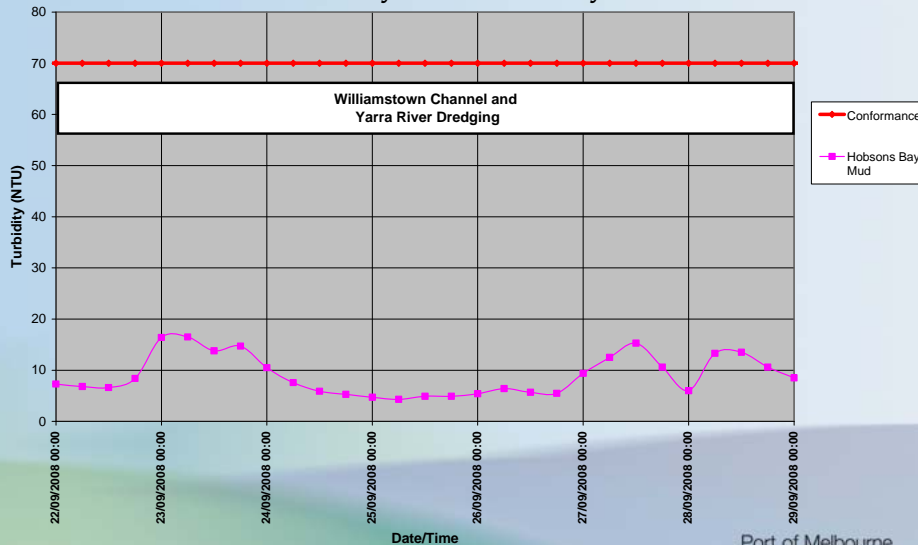
Northern Port Phillip Fish - Turbidity Conformance by 6hEWMA

- Despite prevailing winds and metocean conditions, the data shows all environmental limits are being complied with in the bay
- There were periods of elevated turbidity due to prevailing weather conditions
- This week - as is normal practice - we release data from our **support** sites
- In the north, there is a peak at Newport Power Station intake. The CoZa was dredging uncontaminated clay in overflow mode in an area in close proximity to a buoy. Importantly, conformance remained within environmental limits.
- At the mouth of the Yarra River, elevated levels are due to plume dissipating away from activity at Newport Power Station.
